Manhole Inspection Summary

Manhole # S23K__010MH

Insp Date: **6/12/08 12:16 PM**

Location Address: **323-1412 S Norris**

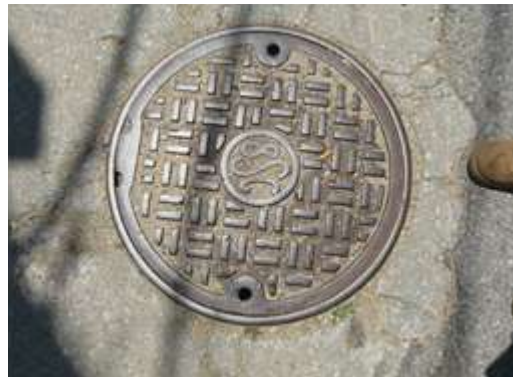
Cover View

Condition: **Worn**

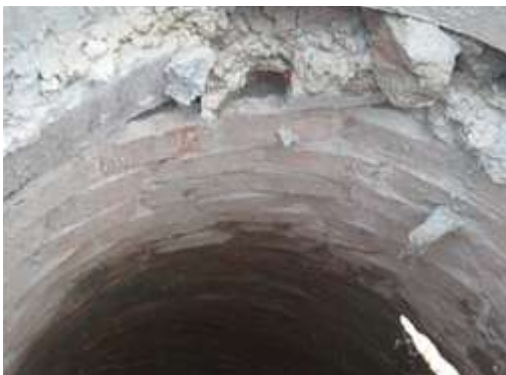
Defect 4

Condition: ☐ Sound ☐ Cracked ☐ Root Intrusion ☒ **Loose Brick** ☐ Deteriorated

loose bricks

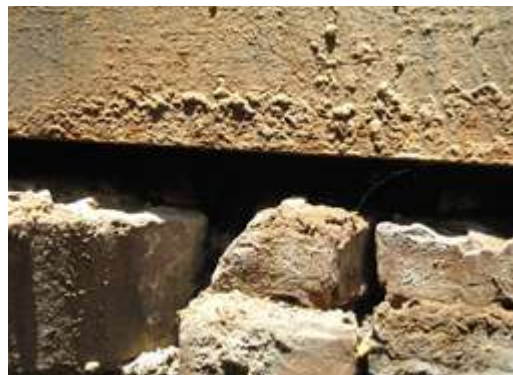
Defect 3

Condition: ☐ Sound ☐ Cracked ☒ **Leaks**

Infiltration: ☐ None ☒ **Joint** ☒ **Cracks** ☒ **Mortar** ☐ Roots ☐ Wall

frame-chimney infiltration missin mortar ,
frame lid infiltration

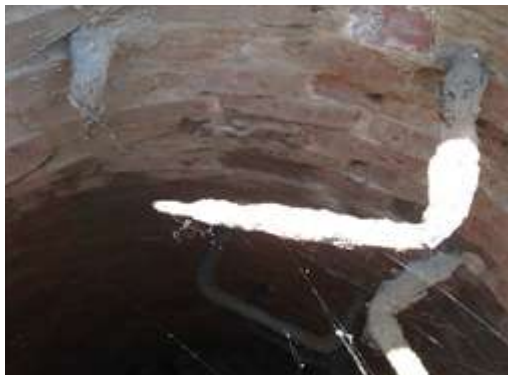
Defect 1

Count: **4** Missing: **0** ☒ **Corroded**

broken corroded rungs
